**Flood Control Project Maintenance  
Levee Inspections**

**Fall 2018 Levee Maintenance Deficiency Summary Report**

**Sacramento River Basin**

**Reclamation District No. 1500 Sutter Basin**

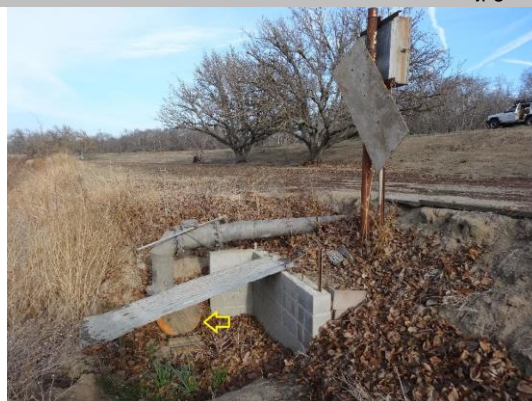
Photo 1 of 3 : UCIP\_FA\_2018\_28183\_51845.jpg

Comment Code						
Inspector Comment						
FS_ID:28183 DS_ID:20032 EP_NO: 1566A Repair Type: Non-Urgent Crossing Status: Found UCIP Comments: - soil erosion around headwall on waterside.- pump was removed.- overhead powerline. FIELD_STRUCT_DESC: *REPLACEMENT CROSSING* 10-inch coated steel irrigation discharge pipe through the levee, 5 feet below the crown. Pump and switch panel on the waterside (WS) berm. Service pole on WS shoulder. Siphon breaker on the landside (LS) slope. 3-foot by 4-foot concrete distribution box at the LS toe. (Replacement of an existing pipeline through the levee authorized under Permit No. 1566-A, 1980 - Ralph White Jr.). [Additional Reference(s): DWR Levee Log, 2005. USACE Sacramento O&M Manual 128, March 1960, (HLM 0.30), 8-inch pipe referenced]. FS Date: 1/9/2014

WS view: concrete blocks headwall and pump on river bank. Pump has been removed (marked). Surface erosion around headwall.

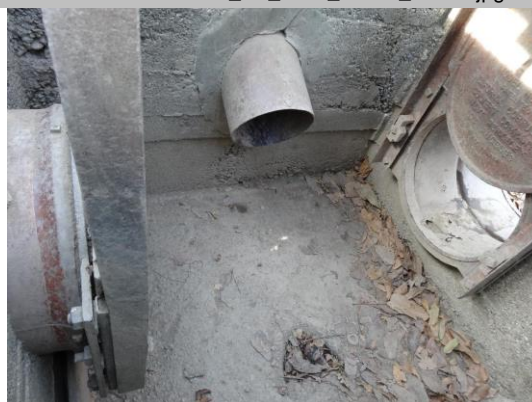
Photo 3 of 3 : UCIP\_FA\_2018\_28183\_51843.jpg

LS view: open steel pipe in concrete distribution box on levee toe.

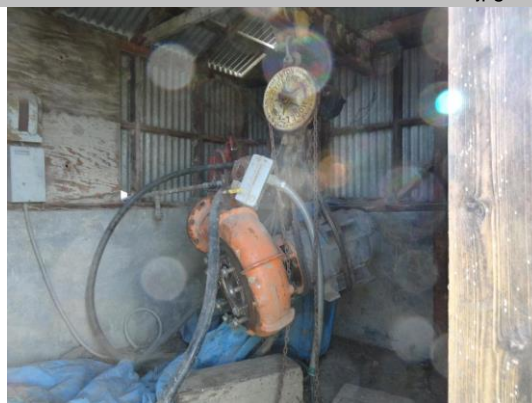
Photo 3 of 3 : UCIP\_FA\_2018\_28903\_53160.jpg

FS\_ID:28903  
DS\_ID:20094  
EP\_NO: 10080  
Repair Type: Non-Urgent  
Crossing Status: Found  
UCIP Comments: Pump removed from concrete pad and kept inside pump house (may be for storage purpose) on waterside. A 8-inch steel pipe inside 14-inch pipe.  
FIELD\_STRUCT\_DESC: 1 of 2: 14-inch steel irrigation discharge pipe through the levee, 5.2 feet below the crown. Pump in a corrugated metal pump house on the waterside (WS) slope. Butterfly valve on the WS. Concrete staircase on the WS slope. 1.75-inch galvanized iron water line with faucet exposed on the landside (LS) slope, 3.4 feet below the crown. 4-foot by 5.7-foot concrete distribution box at the LS toe. 1.25-inch conduit through levee, 2 feet below the crown. (14-inch steel irrigation discharge pipe through the levee and pump in a corrugated metal pump house on the WS slope authorized under Automatic Board Order (ABO) issued as Permit No. 10080, 1974 - Sebastian Yturralde). [Additional Reference(s): DWR Levee Log, 2005. USACE Sacramento O&M Manual 128, March 1960, (HLM 1.28)].

WS view: pump removed from pipe and stored in pump house.

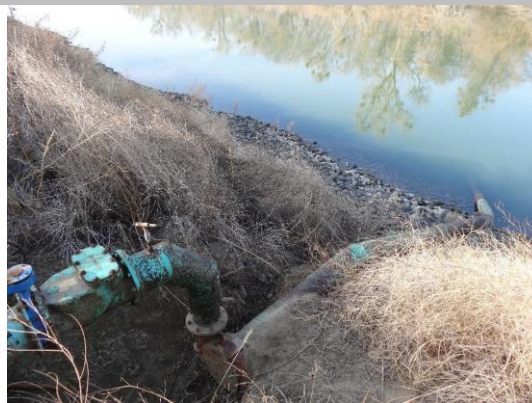
Photo 2 of 3 : UCIP\_FA\_2018\_28204\_51874.jpg

Comment Code						
Inspector Comment						
FS_ID:28204 DS_ID:20033 EP_NO: N/A Repair Type: Non-Urgent Crossing Status: Found UCIP Comments: - pump removed- erosion around pump station.- overhead electrical line. FIELD_STRUCT_DESC: 10-inch steel irrigation discharge pipe through the levee, 10 feet below the crown. Pump and gate valve on the riverbank. Service pole and switch panel on the waterside (WS) shoulder. Pipe crosses irrigation ditch and discharges into a steel distribution box in the field. (10-inch steel irrigation discharge pipe through the levee and pump on the riverbank authorized under Automatic Board Order (ABO) issued as Permit No. 10043, 1974 - Leo Giovanetti). [Additional Reference(s): DWR Levee Log, 2005. USACE Sacramento O&M Manual 128, March 1960, (HLM 1.63)]. FS Date: 1/9/2014

WS view: pump (removed) and inlet pipe on river bank.

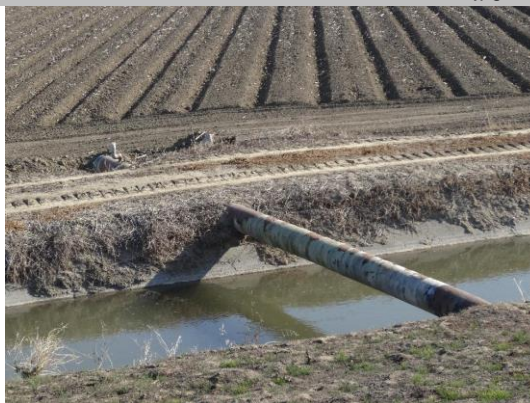
Photo 2 of 3 : UCIP\_FA\_2018\_28264\_51970.jpg

Comment Code						
Inspector Comment						
FS_ID:28264 DS_ID:20035 EP_NO: 10029 Repair Type: Non-Urgent Crossing Status: Found UCIP Comments: - pump removed- outlet plugged- looks abandoned. Found abandoned pipe parts on levee slope and berm.- overhead powerline FIELD_STRUCT_DESC: *ABANDONED* 12-inch steel irrigation discharge pipe through the levee, 11 feet below the crown. Two metal cutoff walls installed. Pumps on the riverbank during irrigation season. Gate valve at the waterside (WS) toe. Pipe discharges into a 2.5-foot by 2.5-foot concrete distribution box on the landside (LS) of the irrigation ditch. (Retention of a 12-inch steel irrigation discharge pipe through the levee and pumps on the riverbank during irrigation season authorized under Automatic Board Order (ABO) issued as Permit No. 10029, 1974 - Merle Anderson). [Additional Reference(s): DWR Levee Log, 2005. USACE Sacramento O&M Manual 128, March 1960, (HLM 2.40)]. FS Date: 1/9/2014

LS view: discharge pipe crossing irrigation ditch on landside.

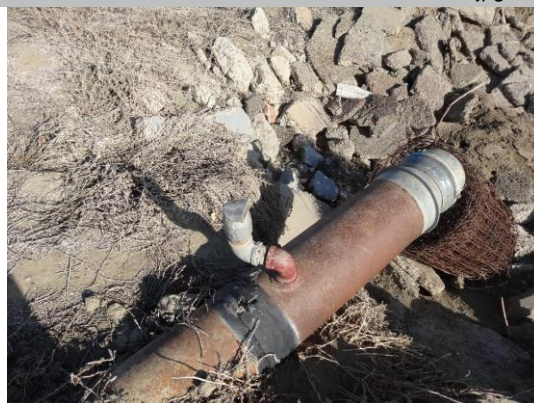
Photo 3 of 3 : UCIP\_FA\_2018\_28264\_51969.jpg

Comment Code						
Inspector Comment						
FS_ID:28264 DS_ID:20035 EP_NO: 10029 Repair Type: Non-Urgent Crossing Status: Found UCIP Comments: - pump removed- outlet plugged- looks abandoned. Found abandoned pipe parts on levee slope and berm.- overhead powerline FIELD_STRUCT_DESC: *ABANDONED* 12-inch steel irrigation discharge pipe through the levee, 11 feet below the crown. Two metal cutoff walls installed. Pumps on the riverbank during irrigation season. Gate valve at the waterside (WS) toe. Pipe discharges into a 2.5-foot by 2.5-foot concrete distribution box on the landside (LS) of the irrigation ditch. (Retention of a 12-inch steel irrigation discharge pipe through the levee and pumps on the riverbank during irrigation season authorized under Automatic Board Order (ABO) issued as Permit No. 10029, 1974 - Merle Anderson). [Additional Reference(s): DWR Levee Log, 2005. USACE Sacramento O&M Manual 128, March 1960, (HLM 2.40)]. FS Date: 1/9/2014

LS view: plugged discharge pipe with air vent across irrigation ditch on landside.

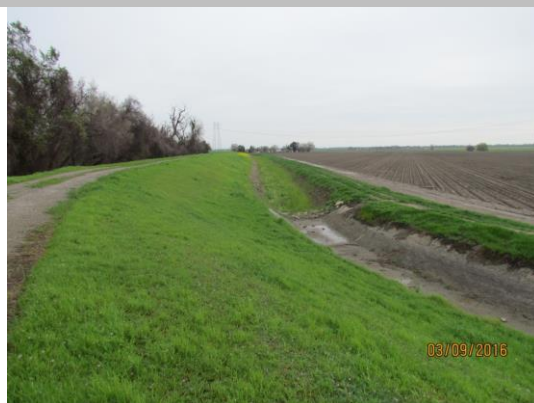
Photo 1 of 1 : FA\_2018\_RD1500\_189\_963\_20180904\_00079.jpg

LM Start	2.54	Rating **	M	Issue No.	963
LM End	3.68	Issue Type +	En	Location *	LS
Category	Earthen Levee			GPS Latitude/Longitude	
				Start	End
Item	Encroachments			38.785351 °	38.797128 °
				-121.689075 °	-121.691047 °
DWR ID	DWR_RD1500_01_s_2012_963				
Comment Code					
DT : Ditch					
Inspector Comment

View of the ditch at the toe of the landward side of the levee looking upstream. Spring 2016.

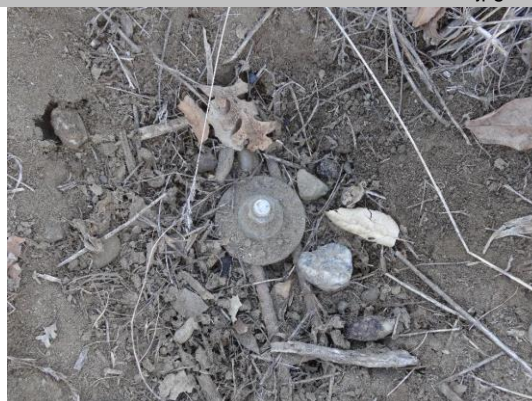
Photo 3 of 3 : UCIP\_FA\_2018\_28913\_53182.jpg

LS view: leaky and obstructed siphon breaker. Depression around siphon breaker due to leakage.

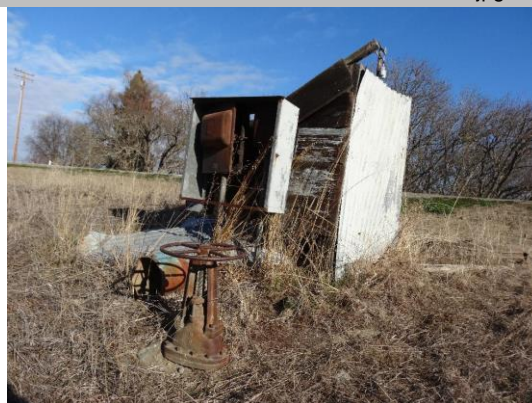
Photo 1 of 3 : UCIP\_FA\_2018\_28923\_53202.jpg

WS view: dilapidated and abandoned CM pump house on berm. Pipe and gate valve also on berm.

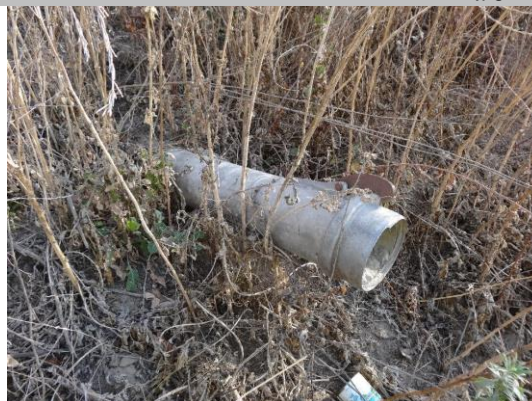
Photo 2 of 3 : UCIP\_FA\_2018\_28323\_52124.jpg

WS view: abandoned steel pipe exposed on river bank.

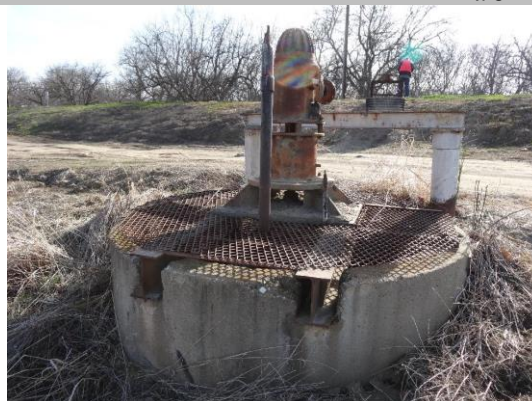
Photo 2 of 3 : UCIP\_FA\_2018\_28324\_52130.jpg

WS view: vertical pump on concrete sump on levee berm. Looks abandoned.

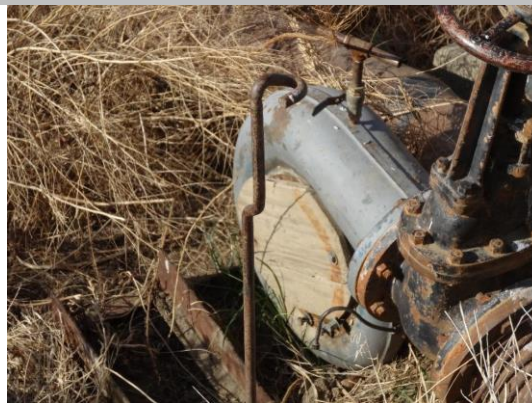
Photo 2 of 3 : UCIP\_FA\_2018\_28343\_52144.jpg

WS view: pipe, pump (removed and capped with plywood), and gate valve on river bank.

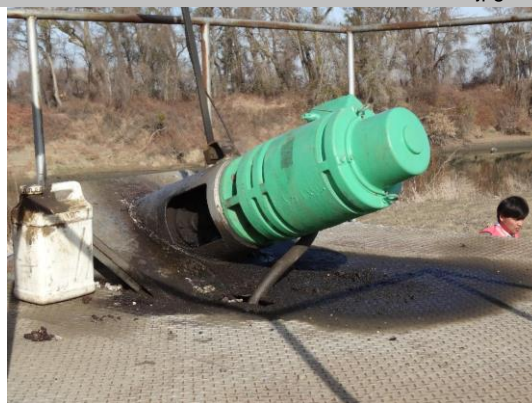
Photo 1 of 3 : UCIP\_FA\_2018\_28364\_52174.jpg

WS view: slant pump on steel platform on levee berm. Excessive oil leak from the pump.

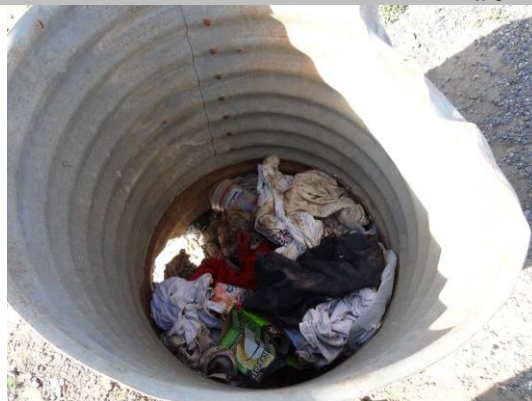
Photo 2 of 3 : UCIP\_FA\_2018\_28365\_52180.jpg

WS view: siphon breaker obstructed by dumped-trash in CMP riser.

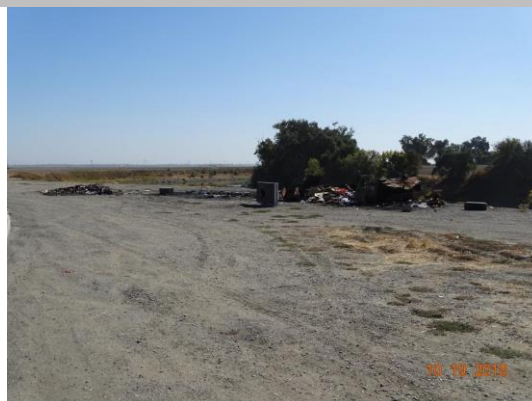
Photo 1 of 1 : FA\_2018\_RD1500\_189\_126\_20181018\_00236.jpg

View of the burned trailer and debris on the waterside berm. Fall 2018.

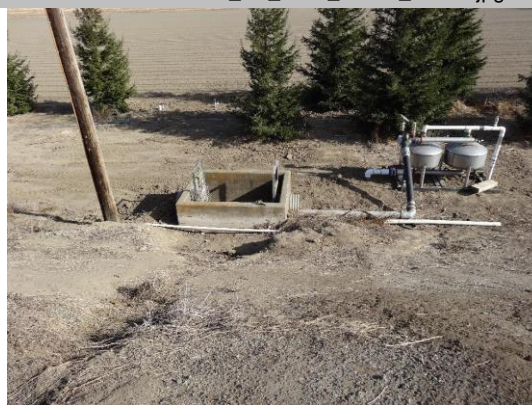
Photo 2 of 3 : UCIP\_FA\_2018\_50198\_52219.jpg

LS view: depressions along the pipe alignment on levee slope. It needs detailed investigation.

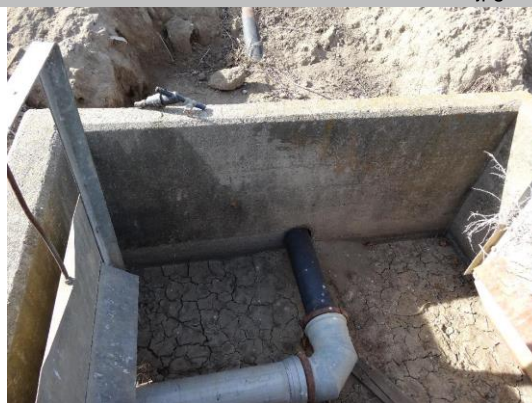
Photo 3 of 3 : UCIP\_FA\_2018\_50198\_52221.jpg

LS view: concrete distribution box on levee toe. Exposed pipe and depression (top) visible on levee slope.

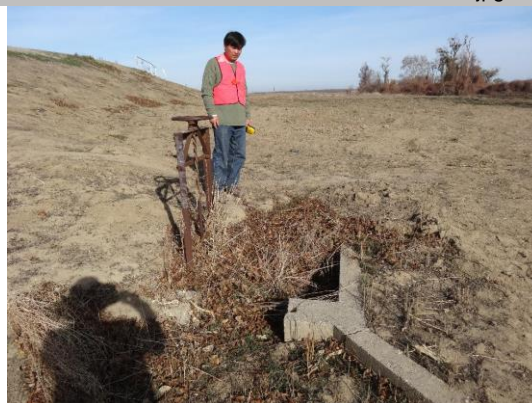
Photo 1 of 3 : UCIP\_FA\_2018\_50197\_52425.jpg

WS view: slide gate (left) in concrete box at levee toe. Slide gate and the box mostly buried.

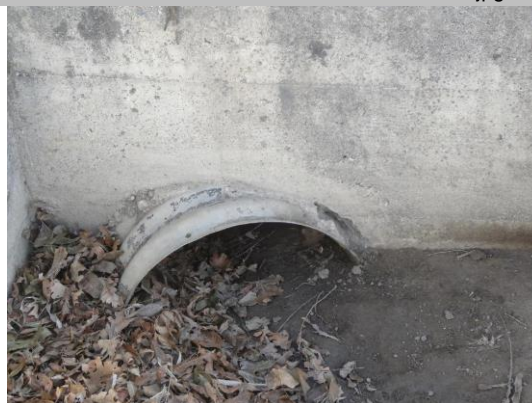
Photo 3 of 3 : UCIP\_FA\_2018\_50197\_52423.jpg

LS view: silted CMP in concrete intake box on levee toe.

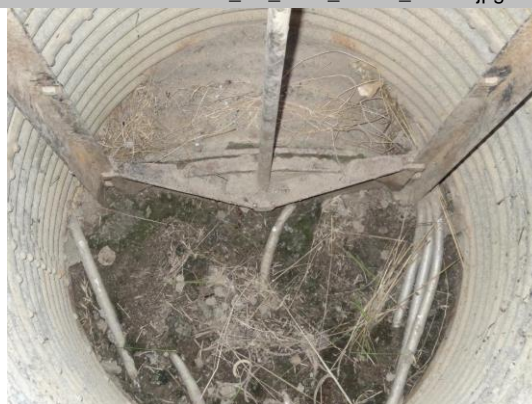
Photo 2 of 3 : UCIP\_FA\_2018\_28489\_52478.jpg

WS view: cleaning and clearing require around slide gate in CMP riser.

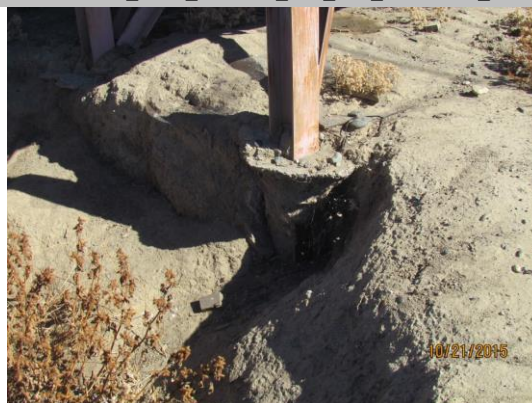
Photo 3 of 3 : FA\_2018\_RD1500\_189\_121\_20180904\_00059.jpg

The concrete for the base stand has been exposed due to erosion.

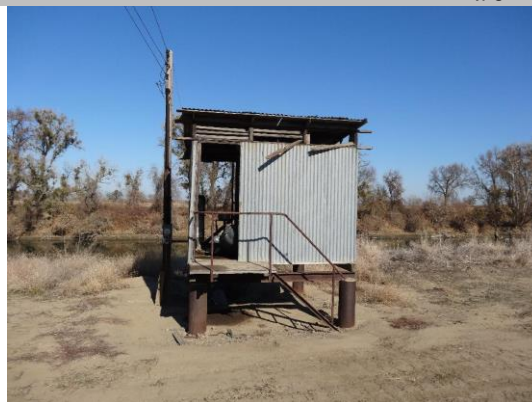
Photo 1 of 3 : UCIP\_FA\_2018\_28505\_52517.jpg

WS view: slant pump in CM shed on levee berm. Oil leaks from the pump.

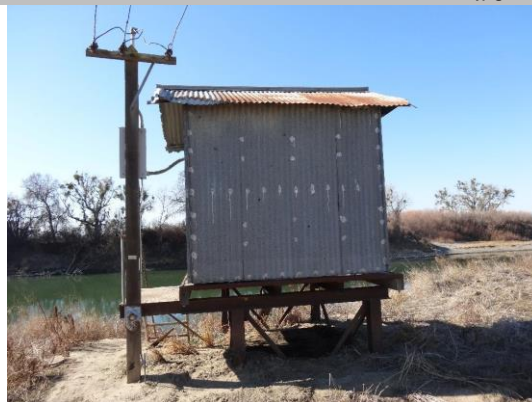
Photo 1 of 3 : UCIP\_FA\_2018\_28506\_52523.jpg

WS view: slant pump in CM shed on levee berm. Oil leaks from the pump.

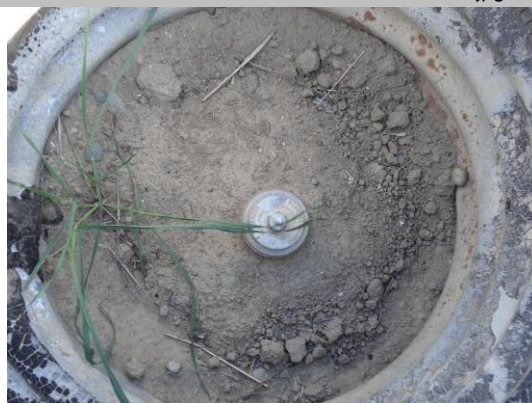
Photo 3 of 3 : UCIP\_FA\_2018\_28527\_52566.jpg

LS view: obstructed siphon breaker in CMP riser on levee slope.

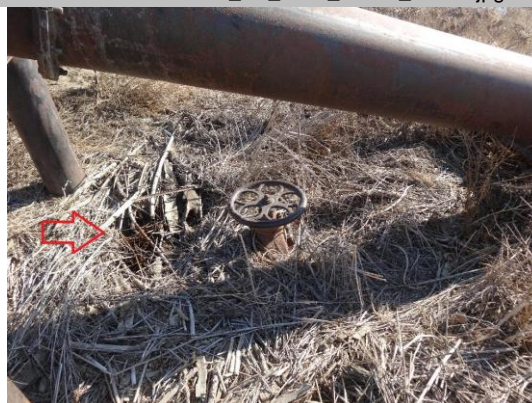
Photo 2 of 3 : UCIP\_FA\_2018\_28583\_52626.jpg

WS view: gate valve beneath slant pipe on levee berm. Water leaking from this pipe (marked).

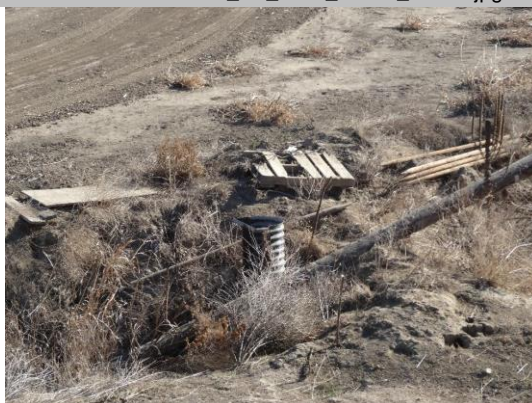
Photo 2 of 2 : UCIP\_FA\_2018\_28629\_52708.jpg

LS view: abandoned CMP risers on levee toe.

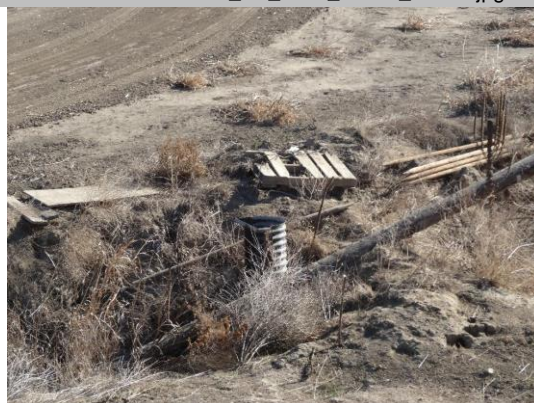
Photo 2 of 2 : UCIP\_FA\_2018\_28628\_52704.jpg

LS view: abandoned CMP risers on levee toe.

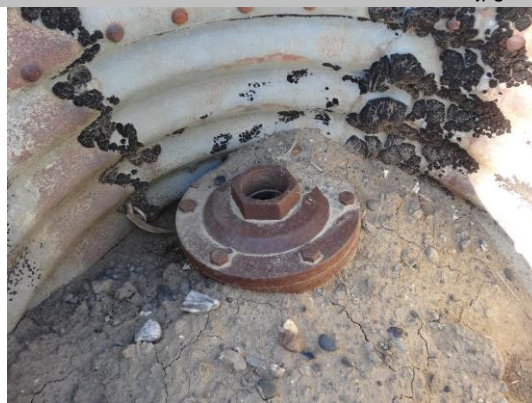
Photo 3 of 3 : UCIP\_FA\_2018\_50201\_52853.jpg

LS view: obstructed and leaky siphon breaker in CMP riser on levee slope.

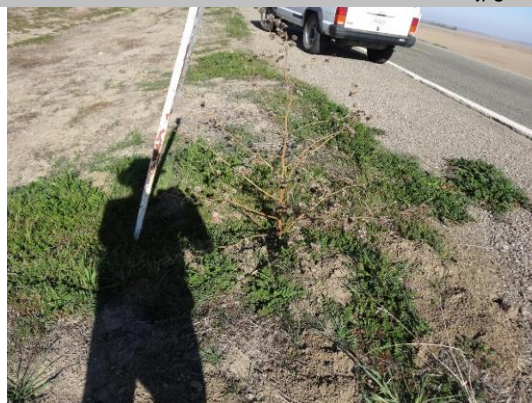
Photo 3 of 3 : UCIP\_FA\_2018\_50193\_51825.jpg

WS view: excessive vegetation along pipe alignment on levee slope.

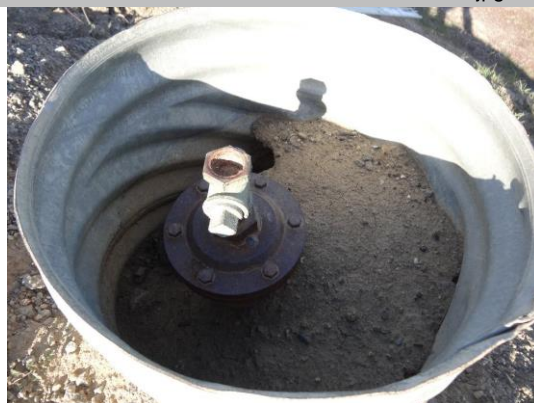
Photo 2 of 3 : UCIP\_FA\_2018\_28144\_51811.jpg

LS view: obstructed and leaked pressure breaker in CMP on levee slope.

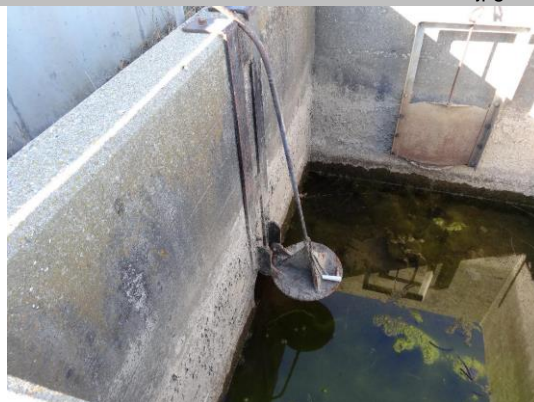
Photo 3 of 3 : UCIP\_FA\_2018\_28144\_51815.jpg

LS view: corroded flap gate in concrete distribution box.

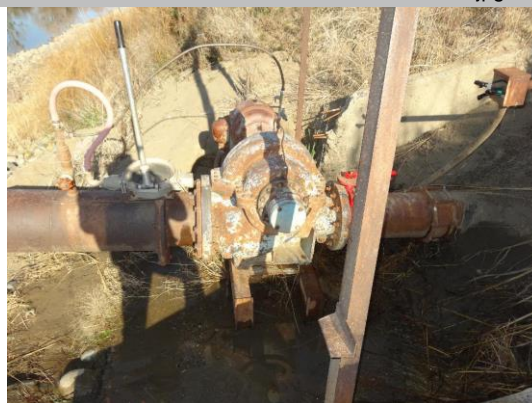
Photo 2 of 3 : UCIP\_FA\_2018\_28943\_53221.jpg

WS view: pump on river bank protected by concrete headwall. Leaky pipe near pump.

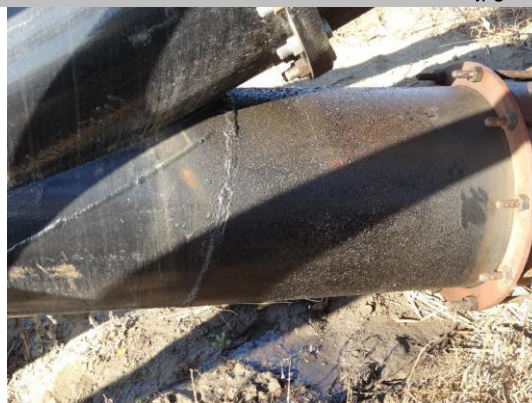
Photo 3 of 3 : UCIP\_FA\_2018\_28953\_53254.jpg

WS view: oil and water leaking from pipe near pump.

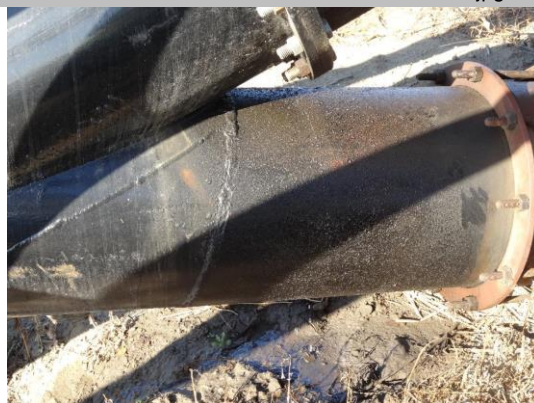
Photo 3 of 3 : UCIP\_FA\_2018\_28952\_53247.jpg

WS view: oil and water leakage from pipe near pump.

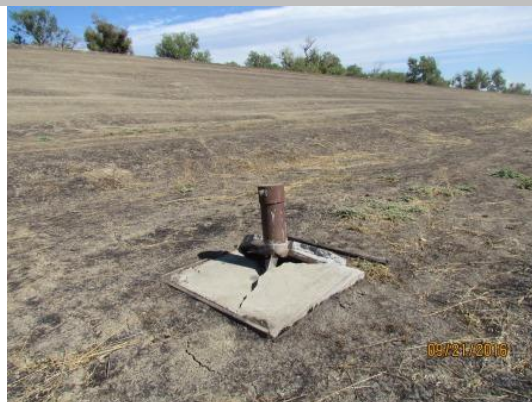
Photo 1 of 3 : FA\_2018\_RD1500\_190\_4\_20180904\_00001.jpg

View of underseepage relief well. Concrete pad as well as PVC pipes underneath are destroyed apparently by an attempt to pull out the head of the well. Fall 2016.
